THE LEUCHTER REPORTS

CRITICAL EDITION

Fred A. Leuchter, Jr., Robert Faurisson, Germar Rudolf
The Leuchter Reports. Critical Edition
5th, corrected and enhanced edition
Uckfield, East Sussex: CASTLE HILL PUBLISHERS
PO Box 243, Uckfield, TN22 9AW, UK

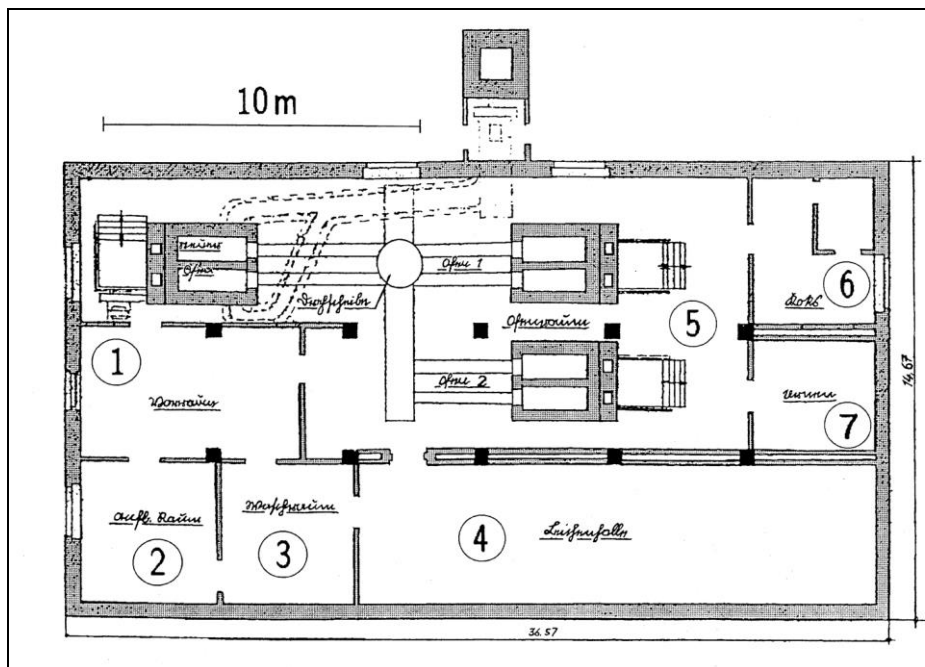
Fig. 5: Ground plan of Crematorium I in Auschwitz I/Main Camp in its original condition. The morgue was later allegedly used as a homicidal gas chamber.¹⁴⁴

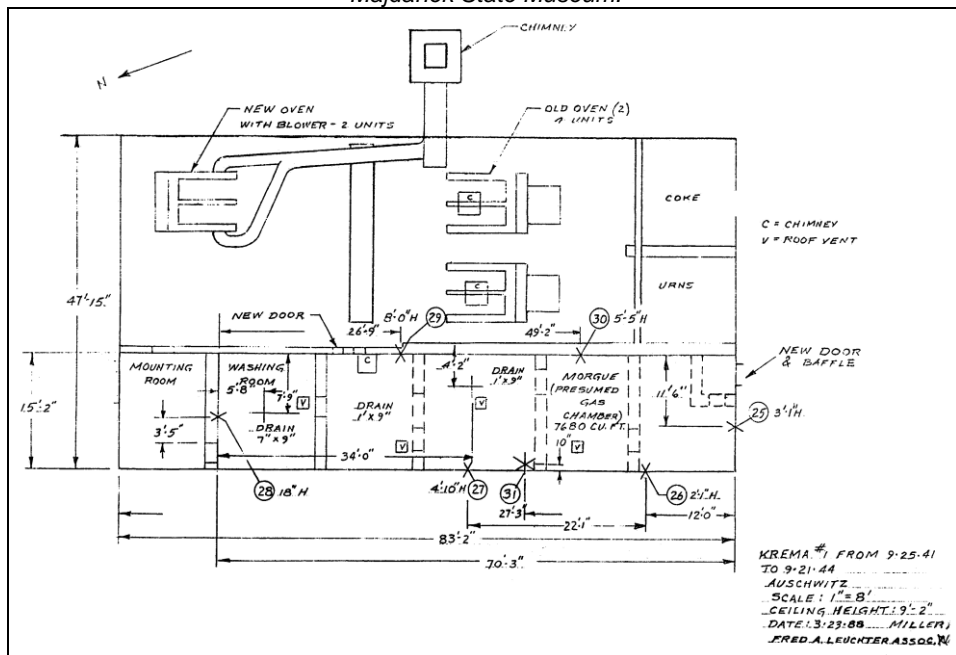
Fig. 13: Floor plan of Krematorium I in Auschwitz main camp, drawn by H. Miller, Fred A. Leuchter Associates. Numbers in circles denote locations where wall sample were taken.

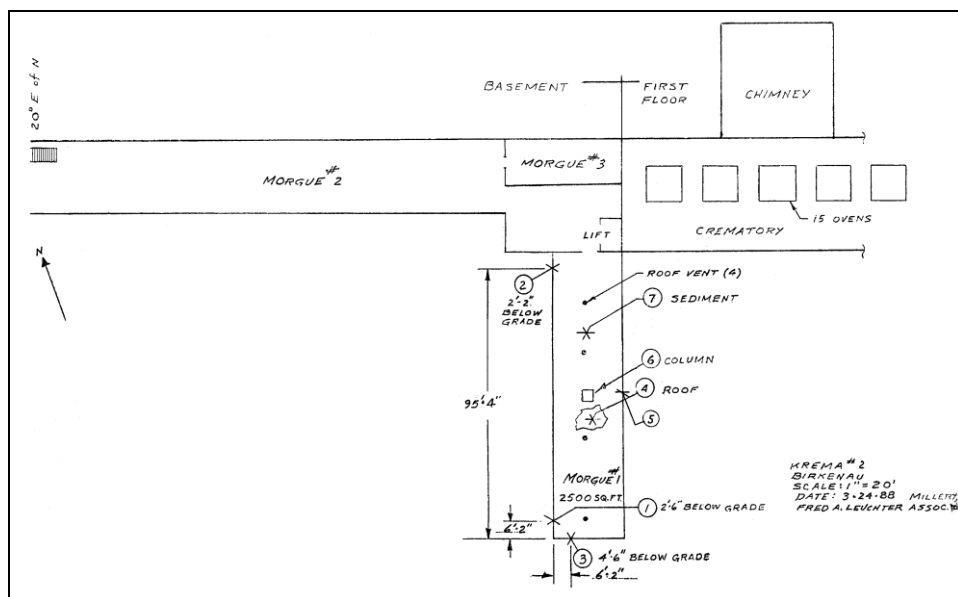
Fig. 14: Floor plan of Krematorium II in Auschwitz Birkenau, drawn by H. Miller, Fred A. Leuchter Associates. Numbers in circles denote locations where wall sample were taken. Note: The "Roof Vent (4)" do not exist; see document on next page.

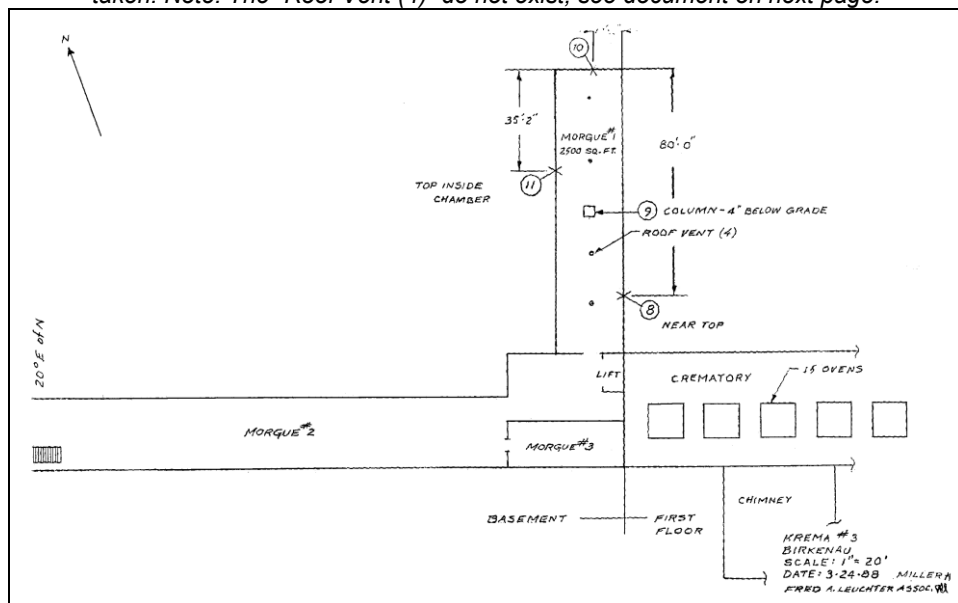
Fig. 15: Floor plan of Krematorium III in Auschwitz Birkenau, drawn by H. Miller, Fred A. Leuchter Associates. Numbers in circles denote locations where wall sample were taken. Note: The "Roof Vent (4)" do not exist; see document on next page.

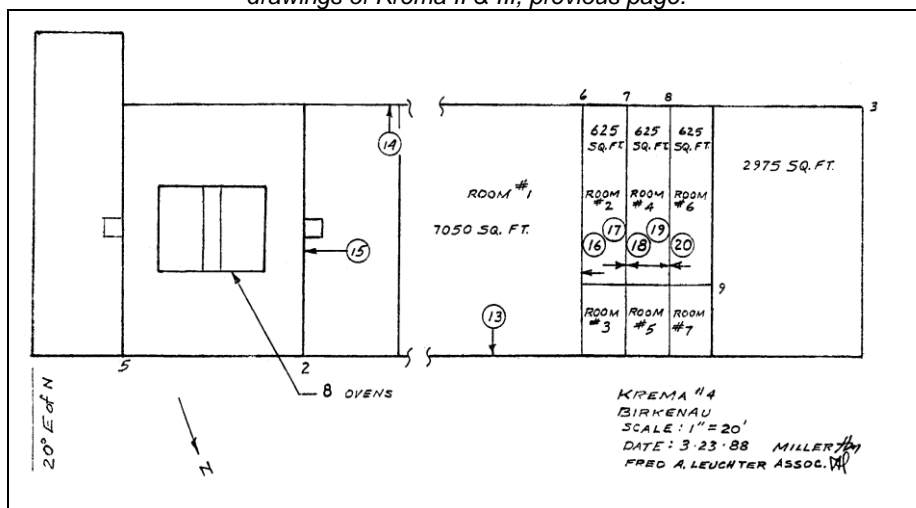
Fig. 17: Floor plan of Krematorium IV in Auschwitz Birkenau, drawn by H. Miller, Fred A. Leuchter Associates. Numbers in circles denote locations where wall sample were taken.

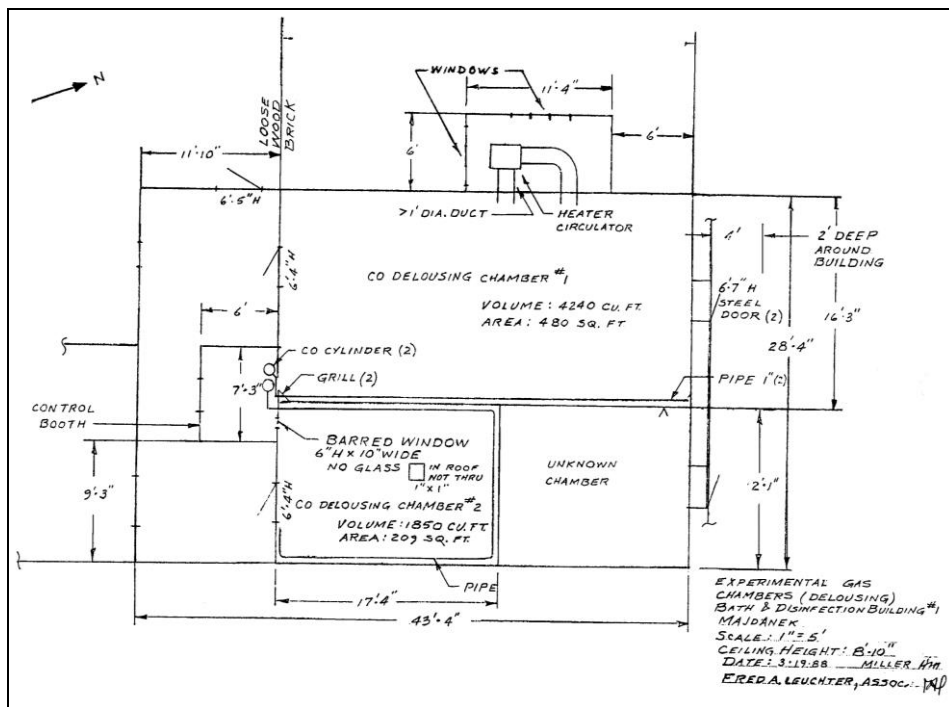
Fig. 20: Floor plan of the delousing wing of Bath & Disinfection Building #1 at the Majdanek camp, drawn by H. Miller, Fred A. Leuchter Associates.

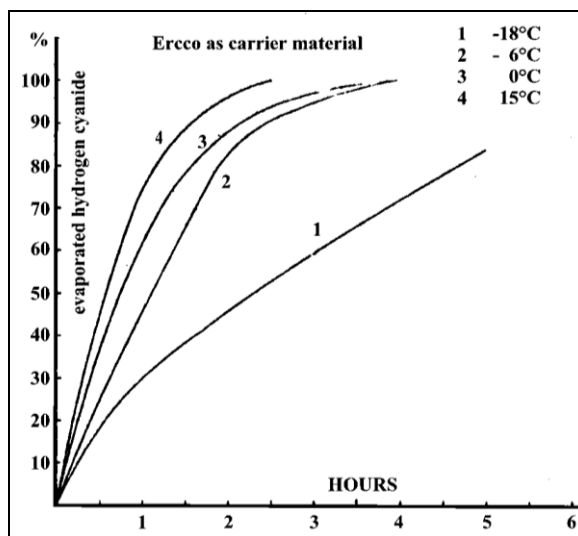
Graph 2: Evaporation rate of hydrogen cyanide from the Erco carrier material (gypsum with some starch) at various temperatures and fine distribution, according to R. Irmscher/DEGESCH 1942.¹⁸²

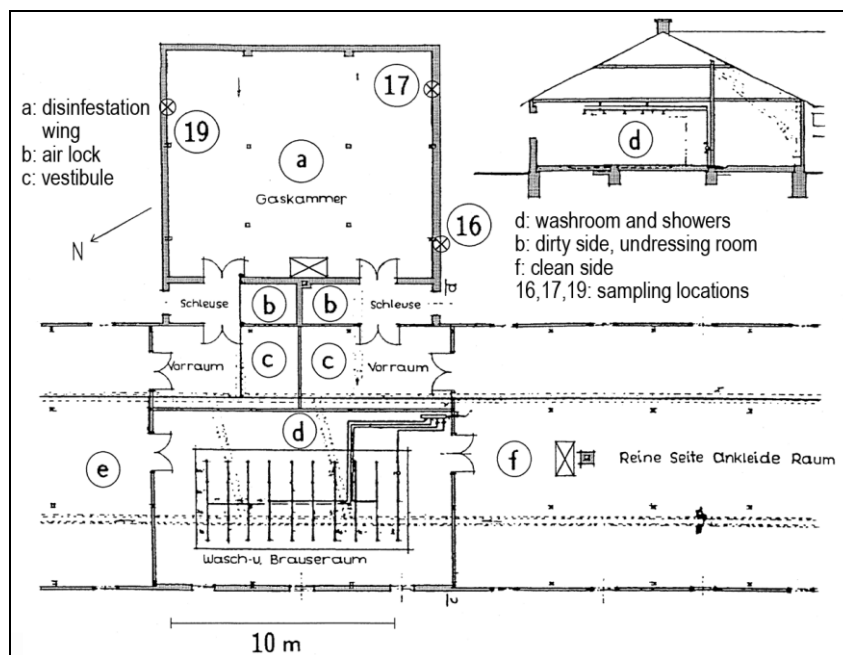
Fig. 24: Ground plan of the HCN disinfestation wing of Building 5a before building alterations (mirror image) and BW 5b today. BW 5b sample-taking locations for the Rudolf Report drawn in.¹⁹⁴

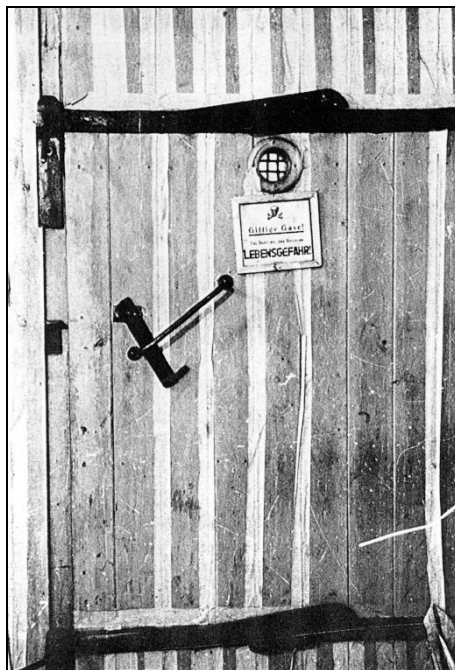
Fig. 26: *Wooden disinfestation chamber door at Auschwitz rendered provisionally gas-tight with peephole and metal protection grid. This is what the gas-tight doors for the homicidal ‘gas chambers’ are supposed to have looked like. Note the extremely flimsy latch to lock the door.¹⁹⁶*

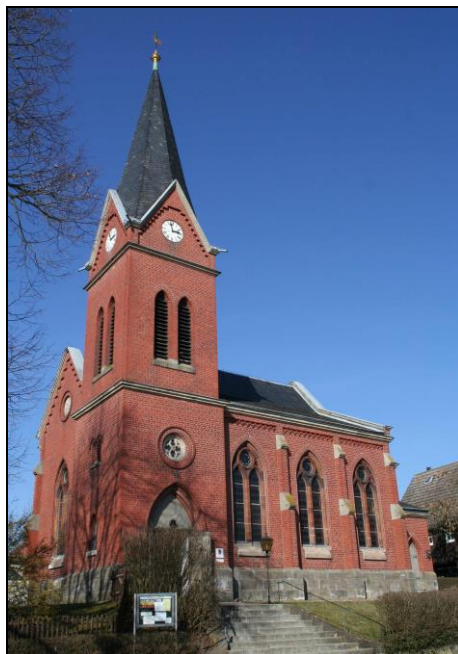
Fig. 36: In August 1976, the Protestant church at D-96484 Meeder-Wiesenfeld was fumigated with Zyklon B. Subsequently, blue-colored stains appeared all over the plaster (see Fig. 37).

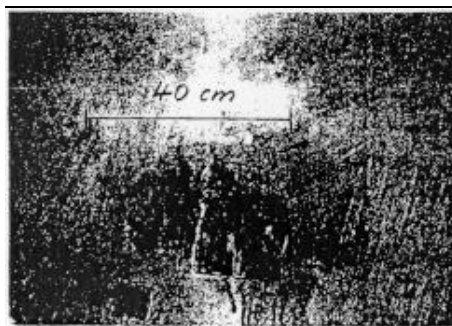
Fig. 37: Inky blue stains on the plaster of a church fumigated with hydrogen cyanide.

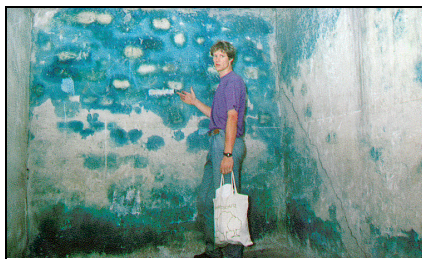
Fig. 38: Blue staining of the interior northwest room in the Zyklon B disinfestation wing of BW 5a in the Birkenau camp. (© Karl Philipp²²⁵)

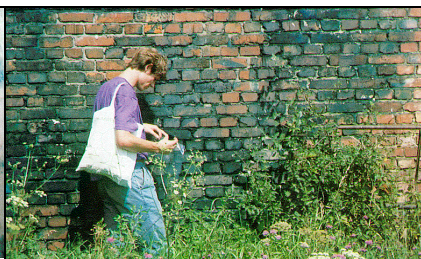
Fig. 39: Blue staining of the exterior southwest wall of the Zyklon B disinfestation wing of BW 5b in the Birkenau camp. (© Karl Philipp²²⁵)

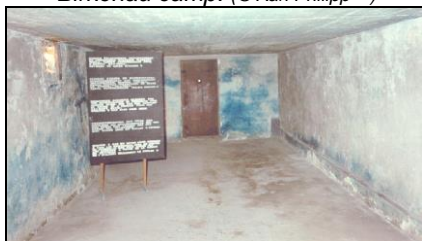
Fig. 40: Blue staining of the Zyklon B disinfestation installation, Chamber III of Barrack 41 in Majdanek Camp. (© C. Mattogno²²⁶)

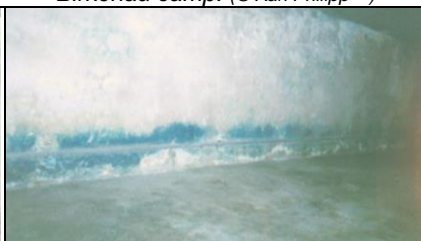
Fig. 41: Blue staining of the Zyklon B disinfestation installation, east wall of Chamber III of Barrack 41 in Majdanek Camp. (© C. Mattogno²²⁶)

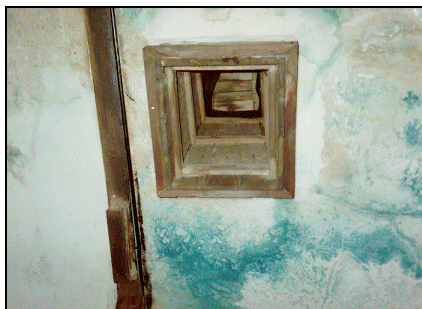
Fig. 42: Blue staining of the large Zyklon B disinfestation chamber, ceiling, Barrack 41 in Majdanek Camp. (© C. Mattogno²²⁶)

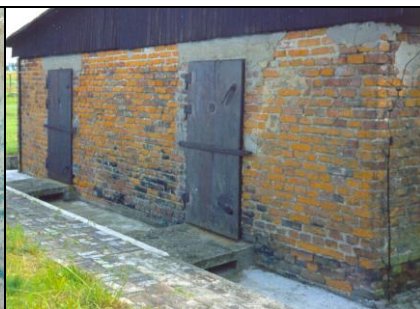
Fig. 43: Blue staining of the Zyklon B disinfestation installation, Chambers II and III (exterior wall), of Barrack 41 in Majdanek Camp. (© Carlo Mattogno²²⁷)

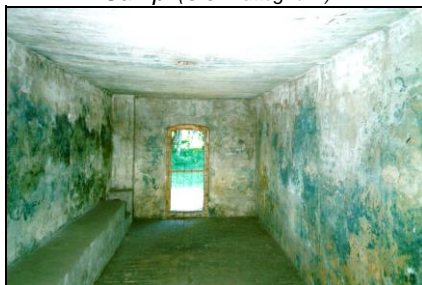
Fig. 44: Blue staining of the Zyklon B disinfestation chamber in Stutthof Camp, interior view taken from the south door. (© Carlo Mattogno²²⁸)

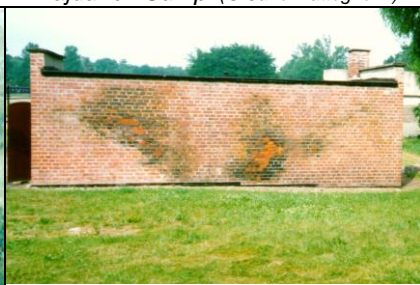
Fig. 45: Blue staining of the Zyklon B disinfestation chamber in Stutthof Camp, east side, exterior. (© Carlo Mattogno²²⁸)

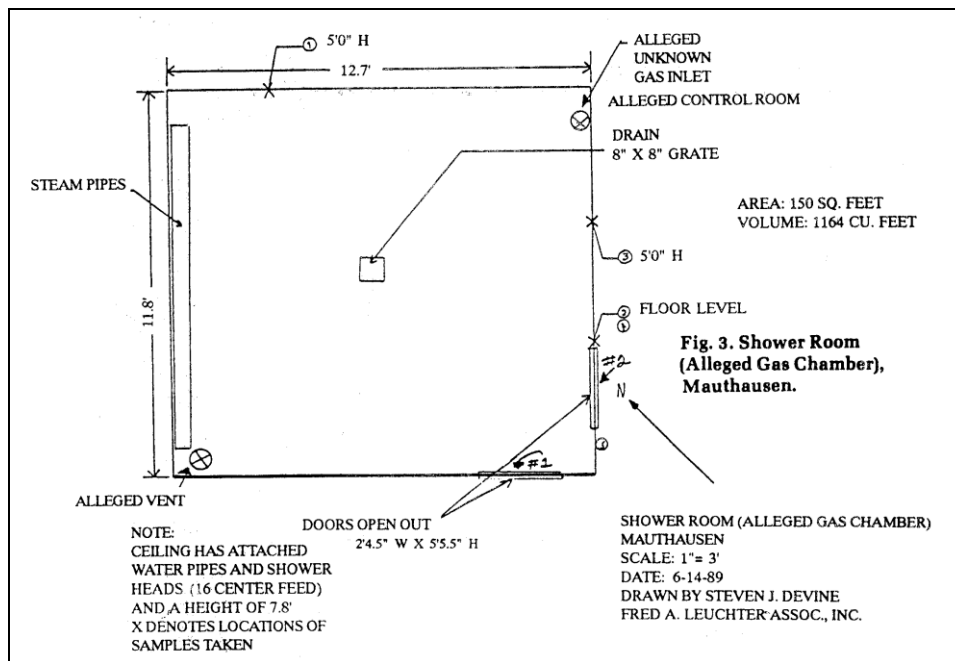
Fig. 49: Floor Plan of the shower (alleged gas chamber) at Mauthausen camp, Austria.
Encircled X denote locations of wall samples taken.

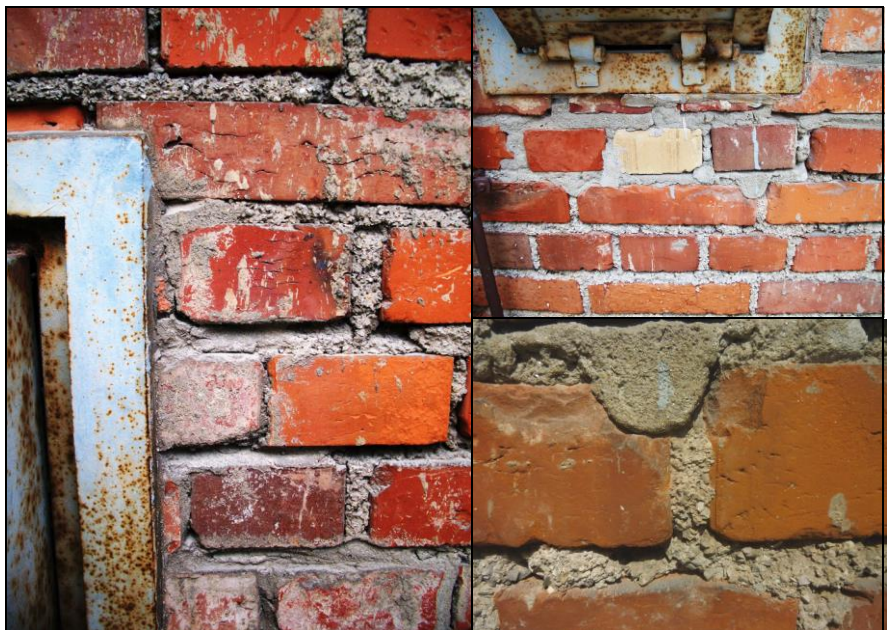
Fig. 50a (left), b, c (right): external view of the alleged “Zyklon B introduction chutes” of the alleged gas chamber at Dachau. The different mortar used for the surrounding bricks proves that these holes were opened only after the wall had already been erected.

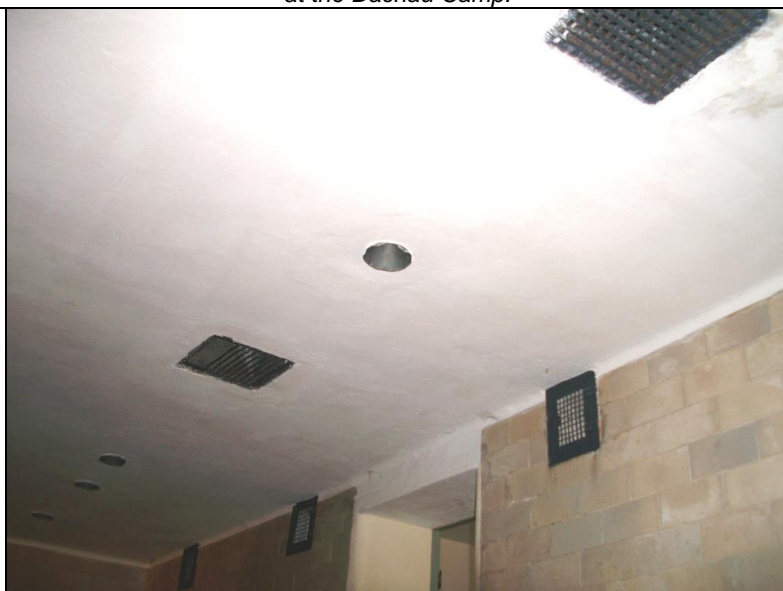
Fig. 65: Ceiling of the alleged gas chamber at the Dachau Camp; circular: four false shower heads; square-shaped with grates: the two air extraction holes. At the wall: three lamp recesses with grates.

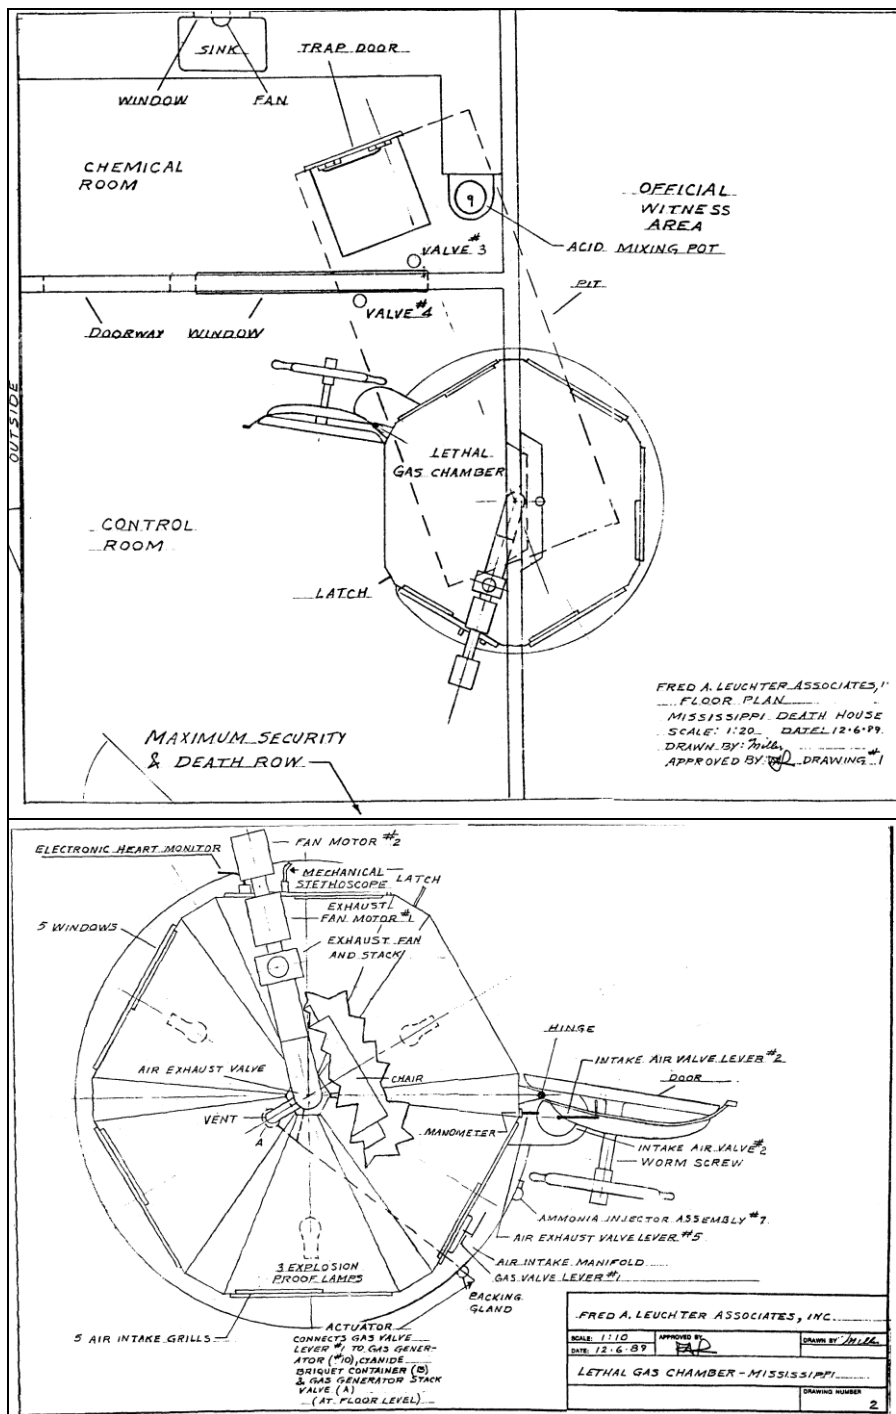
Fig 83 & 84: Technical drawings of the Parchman (Miss.) execution gas chamber.

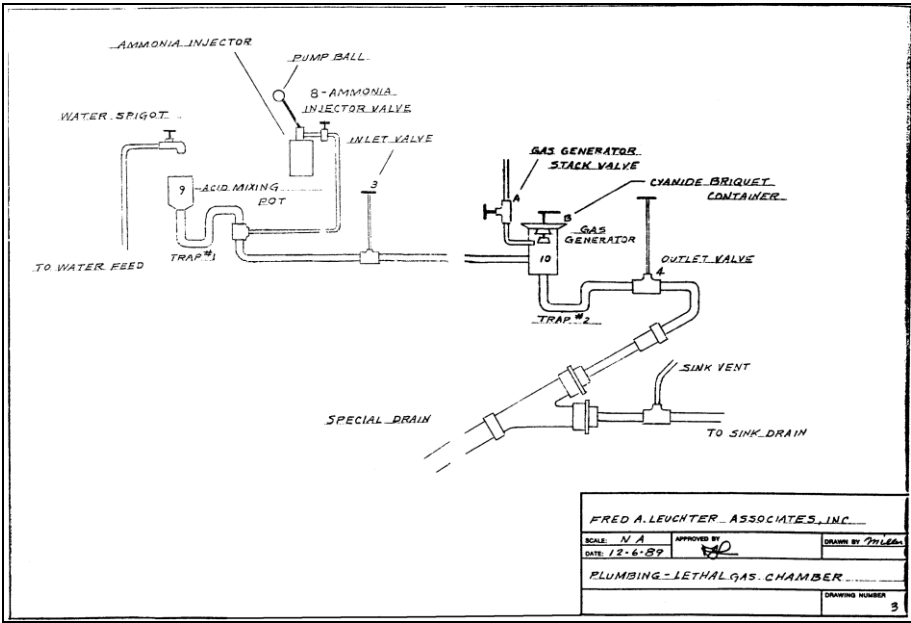
Fig 85: Technical drawing of gas generator of the Parchman (Miss.) execution gas chamber.

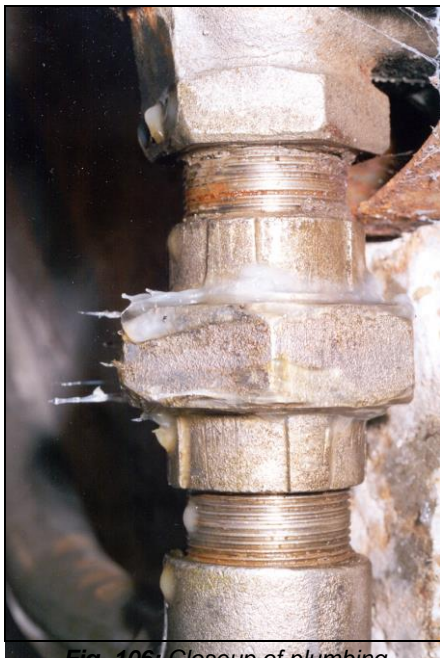
Fig. 106: Closeup of plumbing underneath the gas chamber covered in Vaseline to indicate leaks.

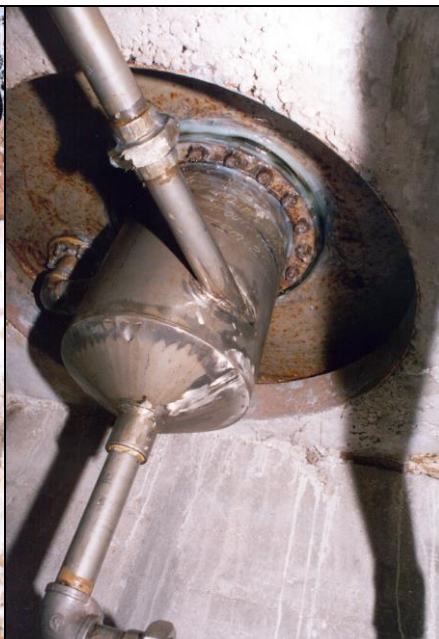
Fig. 107: View of stainless-steel plumbing and chemical container directly under seat in gas chamber.

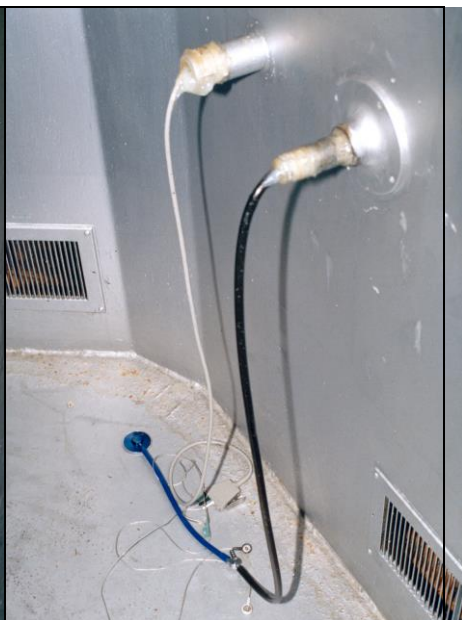
Fig. 111: Inside gas chamber where stethoscope and other body monitoring line enter. They are covered in Vaseline to indicate leaks. Fresh air vents on the walls close to the floor.
